DEPARTMENT OF TRANSPORTATION**DIVISION OF ENGINEERING SERVICES**

Contract #: 04-0120F4Cty: SF/ALA Rte: 80 PM: 13.2/13.9File #: 69.15**SOURCE INSPECTION REPORT****Resident Engineer:**Pursell, Gary**Address:** 333 Burma Road**City:** Oakland, CA 94607**Report No:** SIR-000656**Date Inspected:** 03-Jun-2009**Project Name:** SAS Superstructure**OSM Arrival Time:** 0**Prime Contractor:** American Bridge/Fluor Enterprises, a JV**OSM Departure Time:** 12**Contractor:** Zhenhua Port Machinery Company, Ltd (ZPMC), Changxing Island **Location:** Changxing Dao, Shanghai

OBG Cross Beam 4 (CB4)

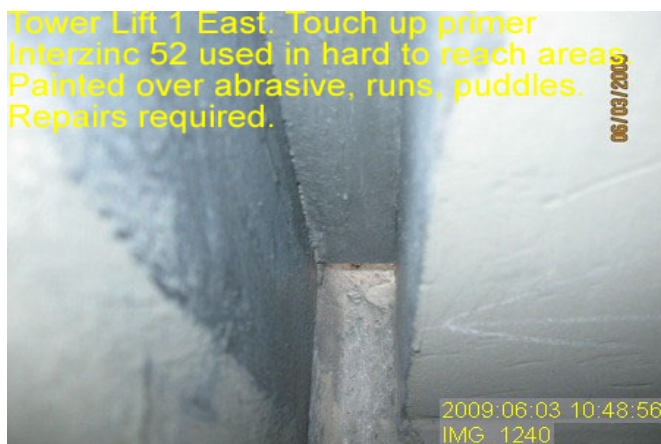
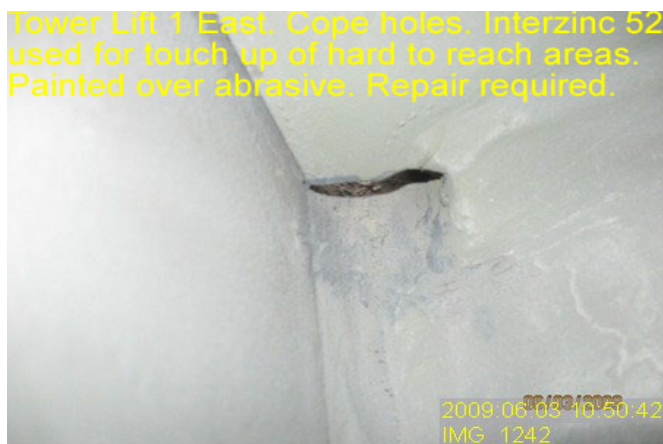
Fabrication on assembled components of the OBG's and Towers are not complete. Outstanding weld repairs have not been performed. Coating damage requiring re-blast is expected.
